Dynamic Tests of Steel Box Beam and Concrete Median Barriers

DYNAMIC TESTS OF STEEL BOX BEAM AND CONCRETE MEDIAN BARRIERS

NO. M & R 636392-3

Prepared in Cooperation with the U.S. Department of Transportation, Bureau of Public Roads January, 1968

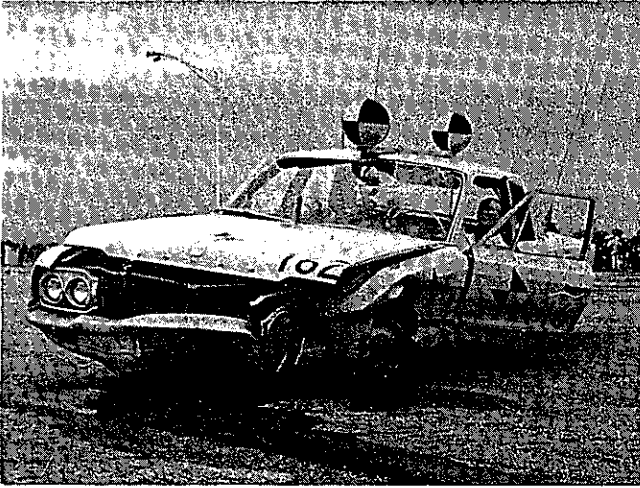
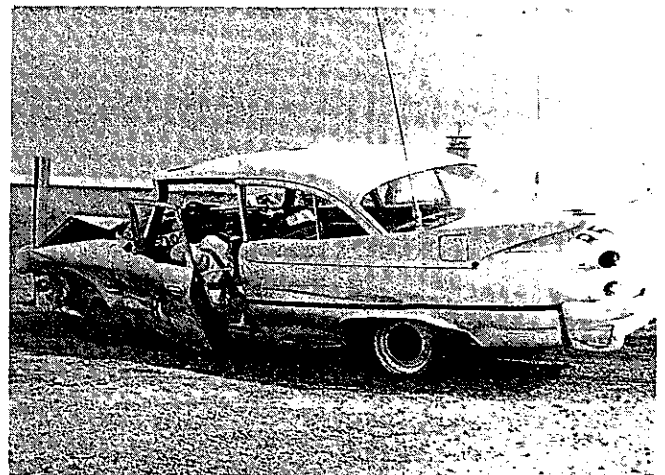
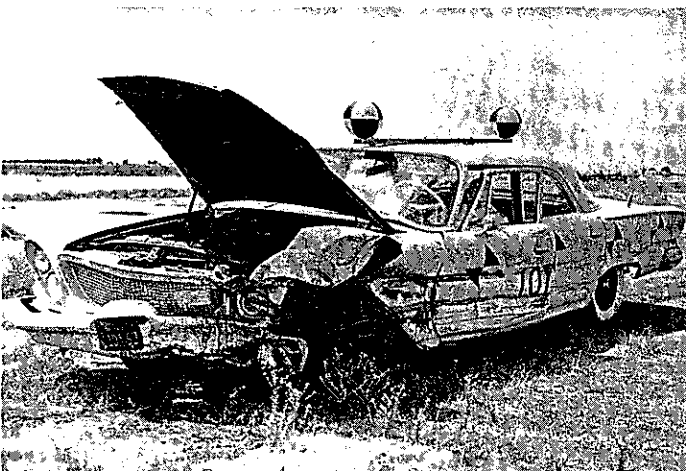
EXHIBIT 7

TEST 162 - NEW JERSEY CONCRETE MEDIAN BARRIER

TEST B-5 CONCRETE PARAPET BRIDGE RAIL (TYPE I)

TEST 101 - "W" BEAM MEDIAN BARRIER

COMPARISON OF VEHICLE DAMAGE ON THREE BARRIER TYPES

Although the damage to the vehicle was considered severe, it was comparable to that sustained in similar high-speed, wide-angle tests on the standard blocked-out beam type barrier and a test on a concrete parapet bridge rail as shown in Exhibit 7 (Appendix).
